# PREVENTATIVE CONSERVATION REPORT

*An assessment of one of Svendborg Museum's stores*

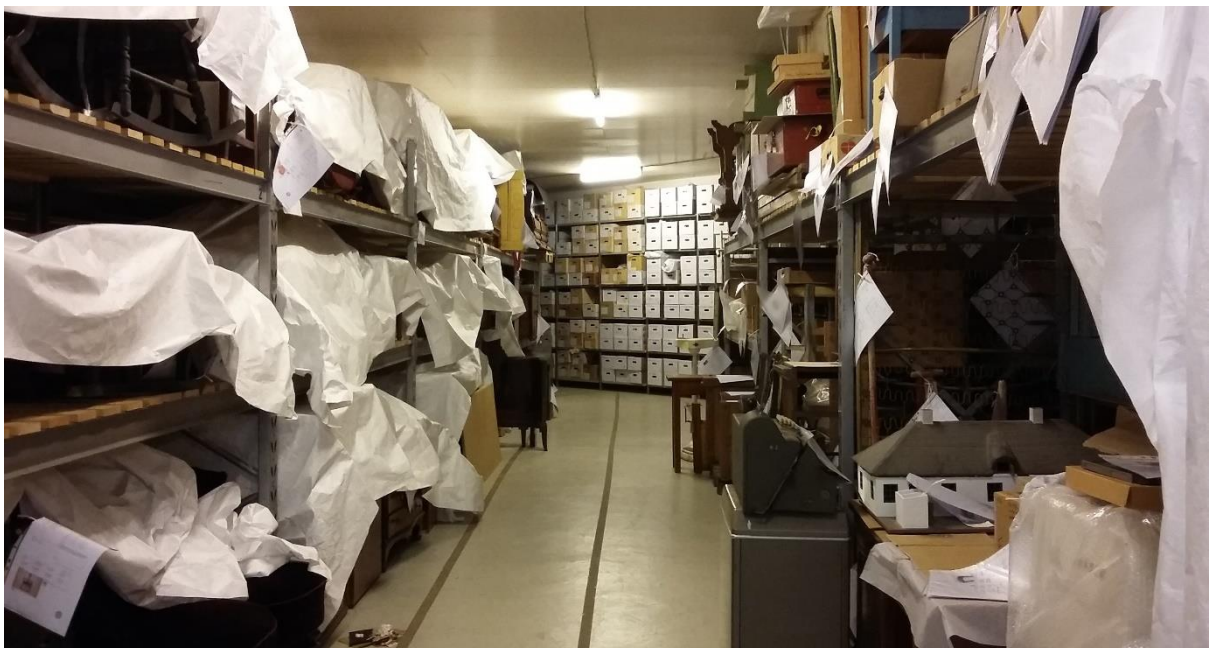
Figure 6: View down one of the aisles of shelves in the main store, showing how things are arranged, and the Tyvek sheets covering some of the objects. The back wall is entirely lined with boxes. Photo by author

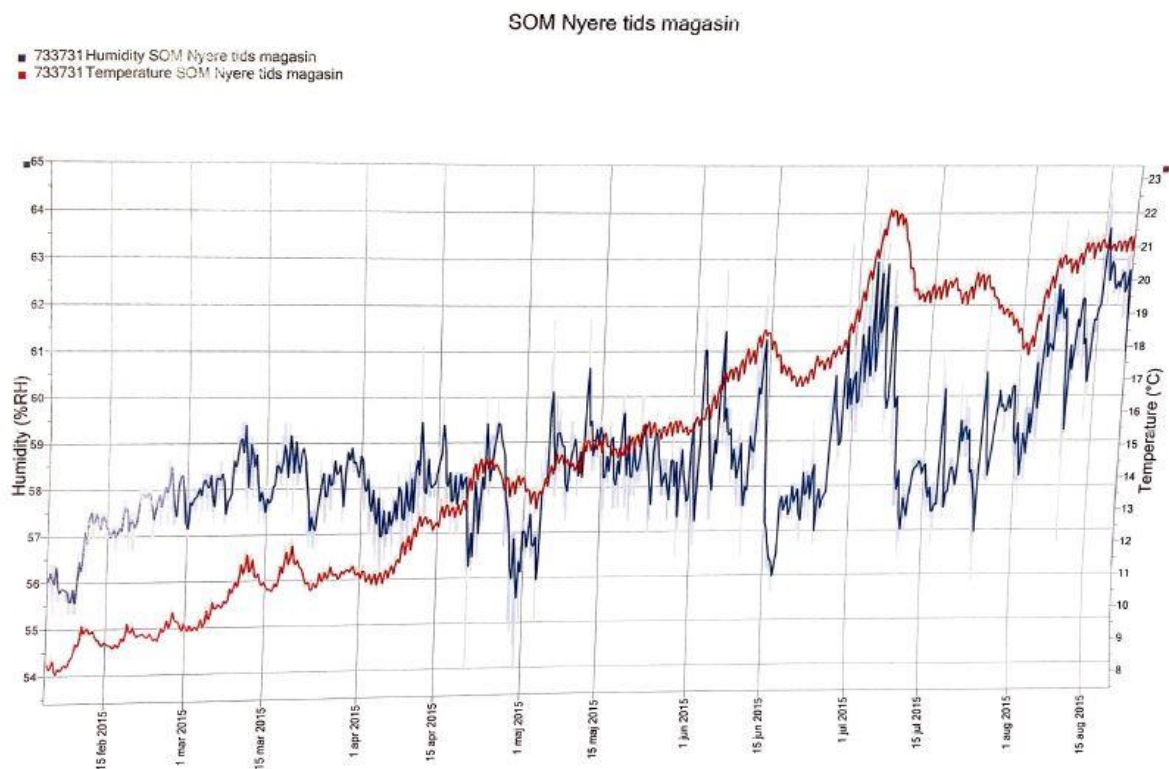
Figure 7: Graph showing relative humidity and temperature for 2015 in the main store room in the store

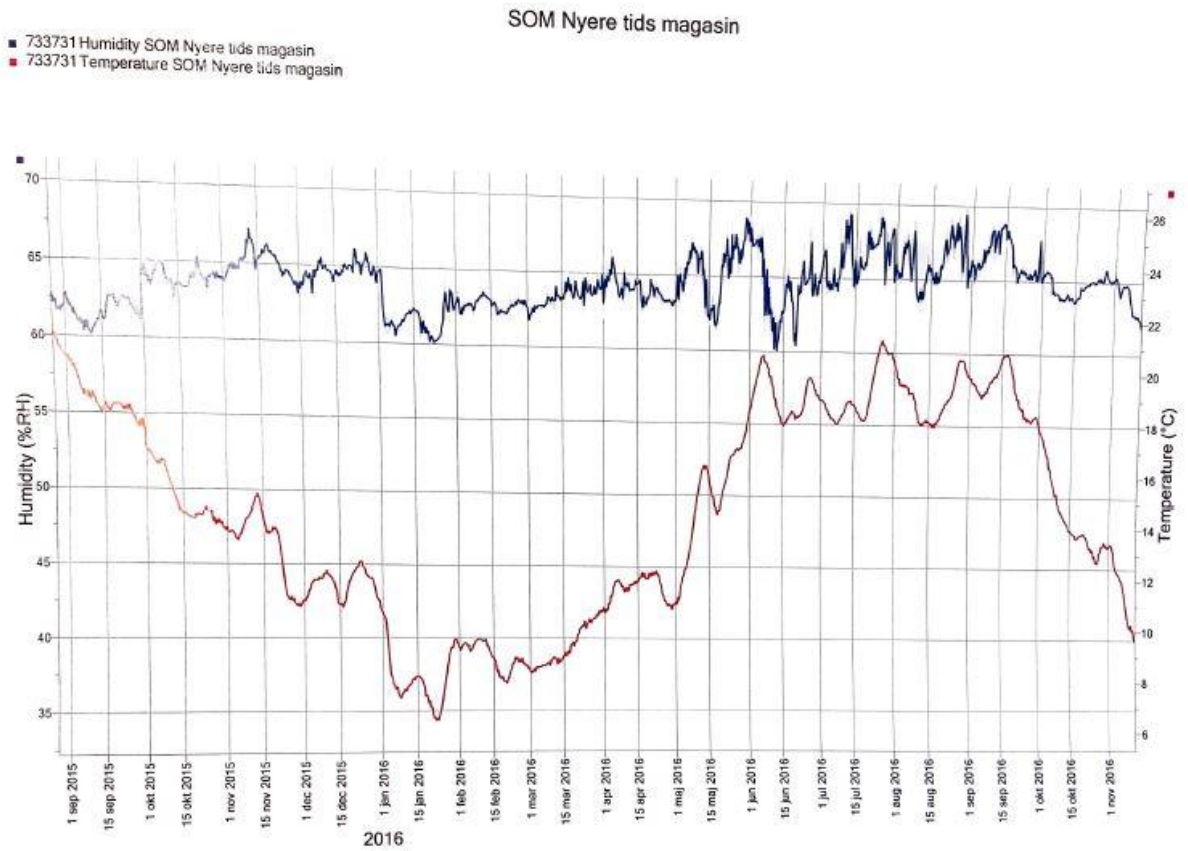
Figure 8: Graph showing relative humidity and temperature for 2016 in the main store room in the store. Note the higher RH compared to the previous year. As the RH sat above 60% for the entirety of the data collection period, it is possible that the later mould problems found in the store developed because of this.

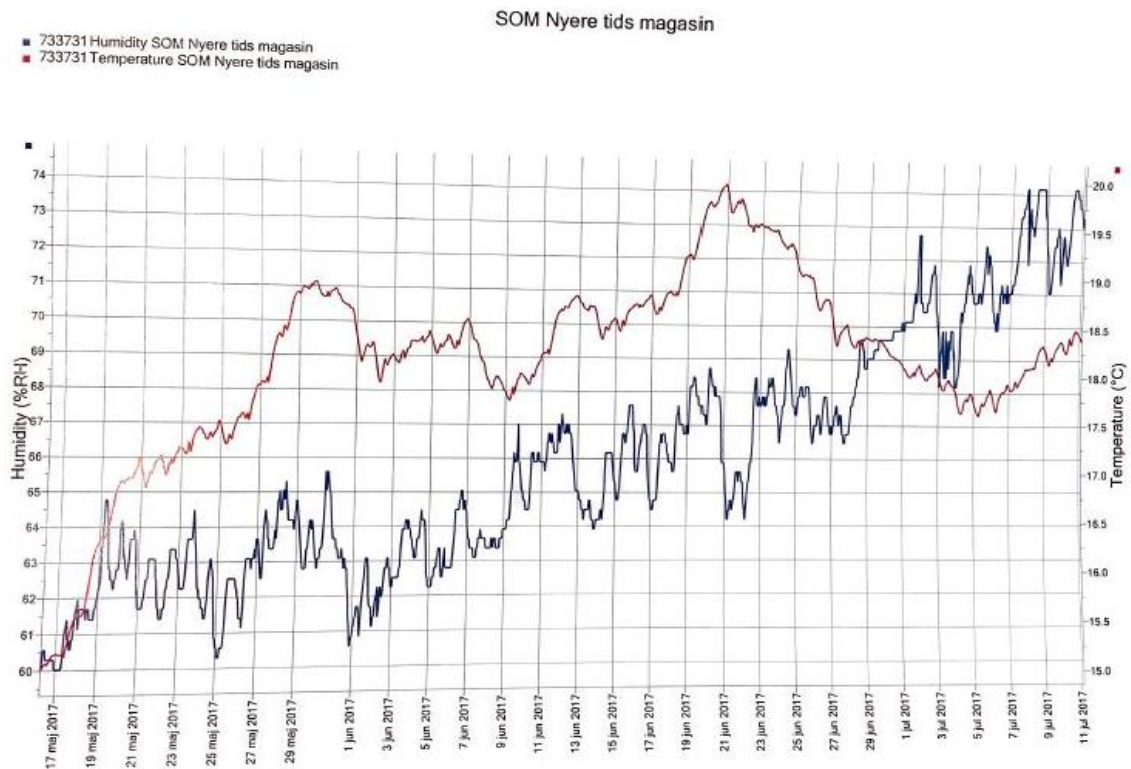
Figure 9: Graph showing relative humidity and temperature for a short period in 2017 in the main store room in the store. The RH continues to be high like the previous year and continues to rise. Though only spanning a few months, the rather steep rise in RH is rather concerning for such a short space of time.

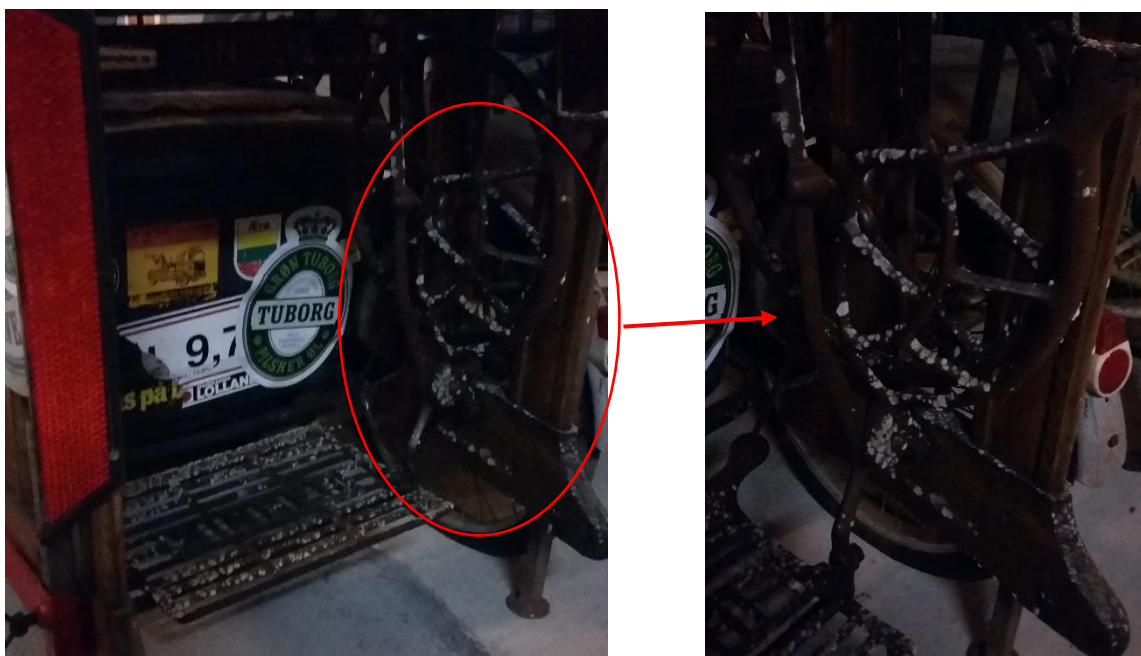
*Figure 10: Mould growing on the metal pedal of a knife sharpening machine (converted from a sewing machine). Attached to a bike that belonged to a homeless man from Svendborg who went around sharpening knives for people all over town during the 1960s and 1970s. The storage containers (covered in stickers) contained all his worldly possessions. He was such an important part of town life at this time, that his bike was given to the museum to preserve his memory. It is likely that the mould was growing on some sort of coating that was on the metal Photos by author*

The previous mould outbreak was treated by museum staff and volunteers. The objects were cleaned with brushes, vacuum cleaners and paper towels, then wrapped in acid-free tissue, and packed into new boxes (Schölch, pers. comm., 2018). Those boxes without mould were kept. The complete set of shelves was moved away from the wall, creating an area for air flow. The continued use of boxes that had been close to the mouldy boxes may present a problem, as the spores may remain within the cardboard (Sterflinger, 2010: 48), though at the time of writing, no mould growth has been noted in this area, despite the recent outbreak in the rest of the room. This outbreak was more widespread than the previous (Fig. 16). For the period between 16 Oct. 2017 and 15 Dec. 2017, the author and Simon Schölch spent at least 2 days a week cleaning and treating the mouldy objects in the store (for treatment details see Experimental Report). The cleaning of objects continued well after this period, but occurred in the lab, as the remaining objects were small enough to be easily transported, allowing for more comfortable working conditions and better health and safety for those working. During this treatment period, a dehumidifier was installed in the store. Though only 6 months of data are available since the dehumidifier was installed, a noticeable difference can be seen (Figs. 17). The RH varies less drastically (except for odd spikes- there were some problems with the machine's sensor settings during the first few weeks) than before. In comparison to the beginning of October 2017, when work first began, the air feels noticeably drier and less fusty (as of May 2018).

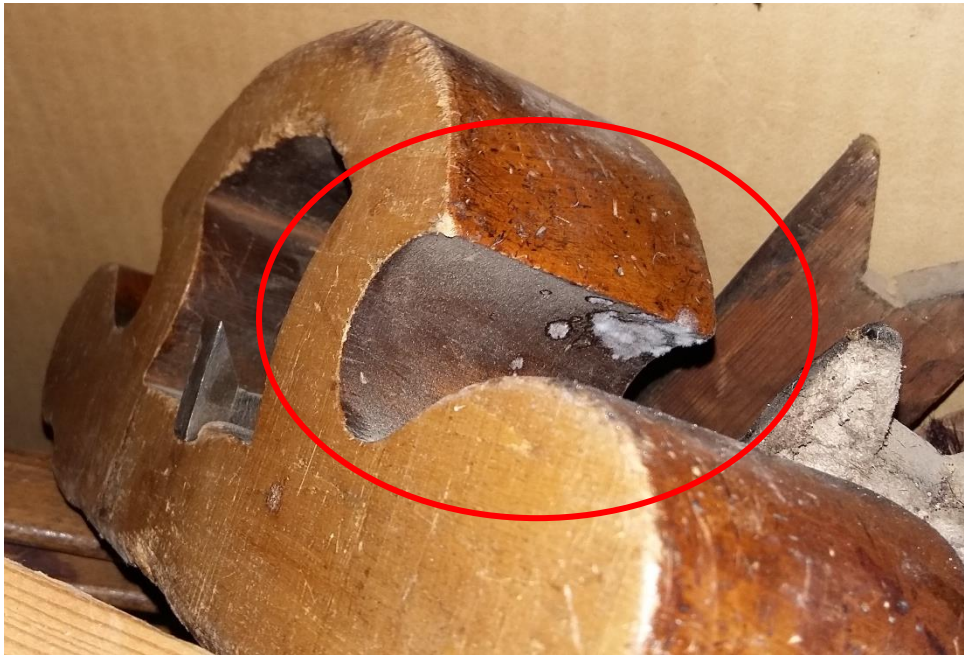
Figure 11: Mould growing on a wooden object. Note the amount of dirt and dust build up in the area around the mould. It is likely that the mould began growing on that. Photo by author

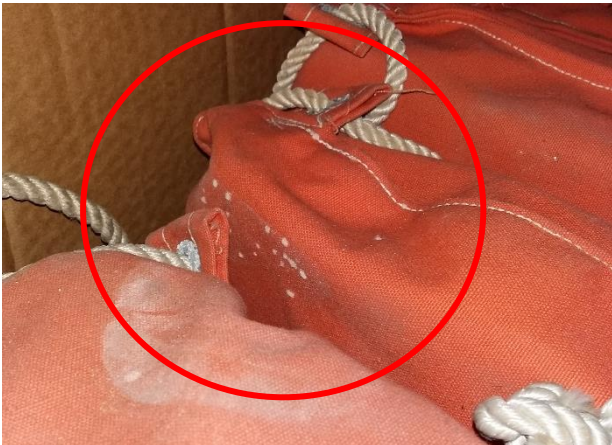
Figure 12: Mould growing on life jackets (textile) in the store. Photo by author

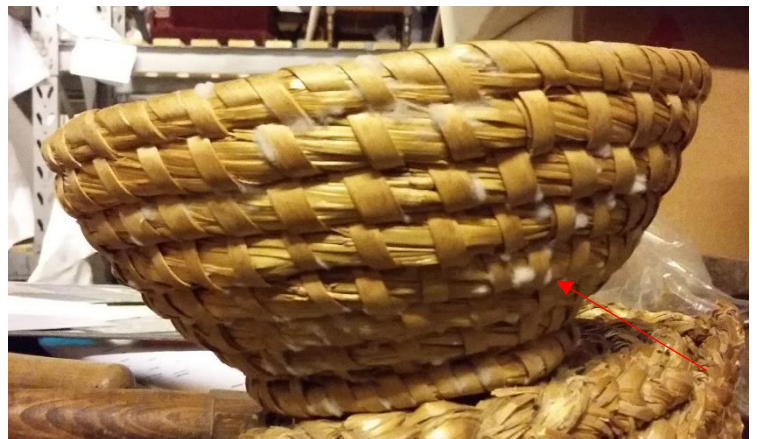
Figure 13: Mould growing on a basketry bowl. Photo by author

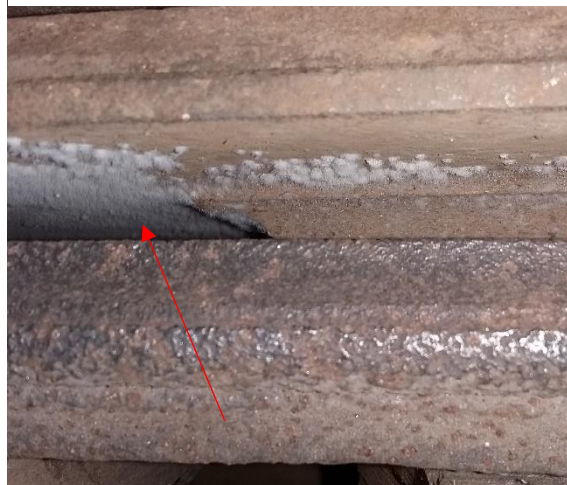
Figure 14: Mould growing between metal (iron) panels which assemble to form a stove. Photo by author

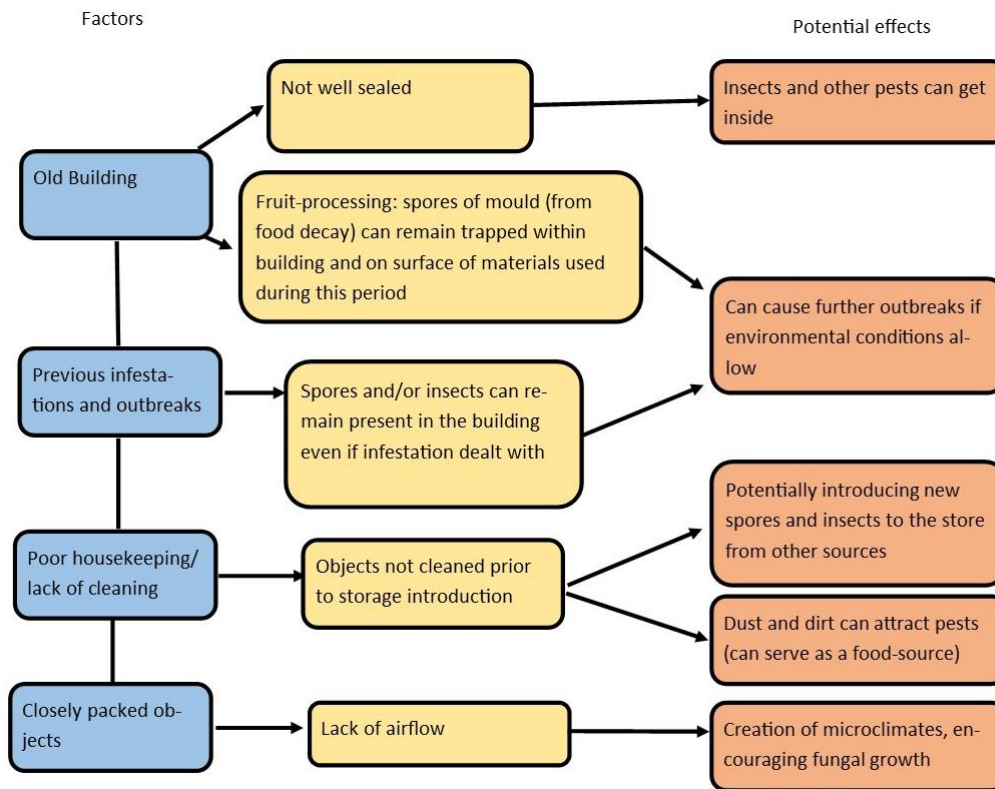
Though such outbreaks and infestations may be caused by multiple factors at once, not all of which can be identified, there are several clear influences in this case:

Figure 15: Diagram of the factors behind the store's problems, as well as how they might affect the collection

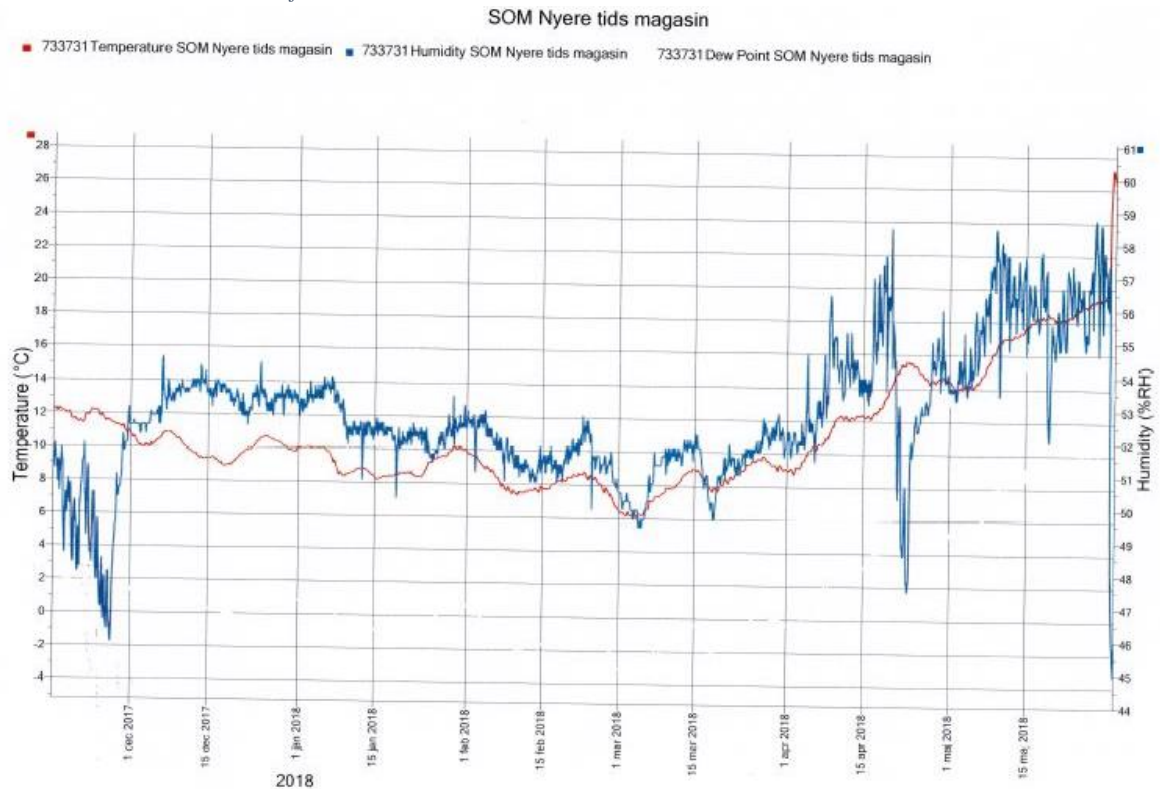
Figure 17: Graph showing the relative humidity and temperature data collected between Dec 2017 and May 2018 in the main store room. Except for the beginning and end of the period, the RH appears to be more stable, and the range, rather than being above 60%, is between 45% and 58%, which is far more acceptable for the collection and more likely to inhibit mould outbreaks and insect infestations.
